# REPAIRS TO THE MODERN CROSS ON RIDGE, NORTH HILL

Cornwall Archaeological Unit  
Cornwall County Council  
May 2000

## **REPAIRS TO THE MODERN CROSS ON RIDGE, NORTHILL**

Ann Preston-Jones

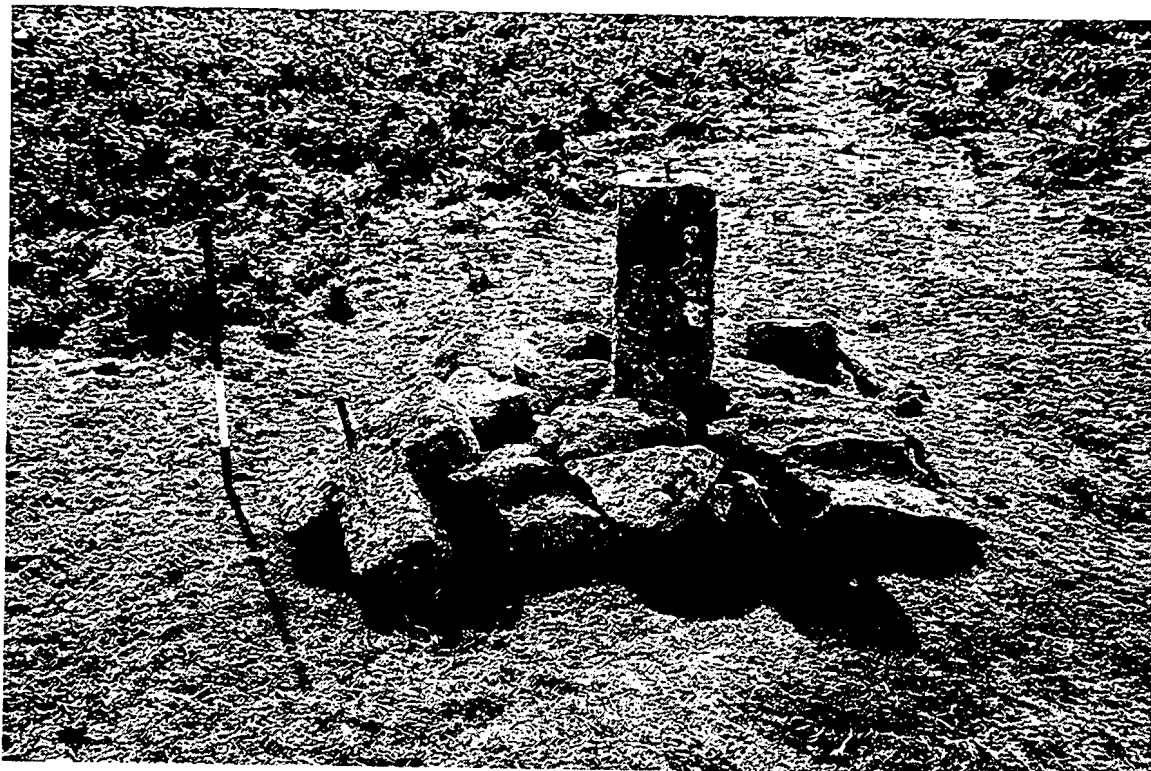
The damage was to the upper part of the head. The horizontal arms and upper vertical arm had broken off, perhaps as a result of cattle rubbing against it. The iron clamp down the back of the cross, which effectively united the three sections of granite, had long been broken, but the head had somehow been lifted free of the central iron pin and been completely dislodged from the shaft (Fig 3). To allow this to happen, the cement filling the joint must have cracked, allowing water in which corroded and weakened the pin. The joint between the horizontal and top arms appeared secure and apparently stable.

*Fig 3 The damaged cross: note the recently detached cross-head lying beside the corner of the rubble cross-base (photo by Dave Hooley)*

Because the cross is such a significant local landmark, it was decided that the head should be replaced and the cross restored as soon as possible. This took place on Friday 17th January 2000, with the work being recorded by photograph and description.

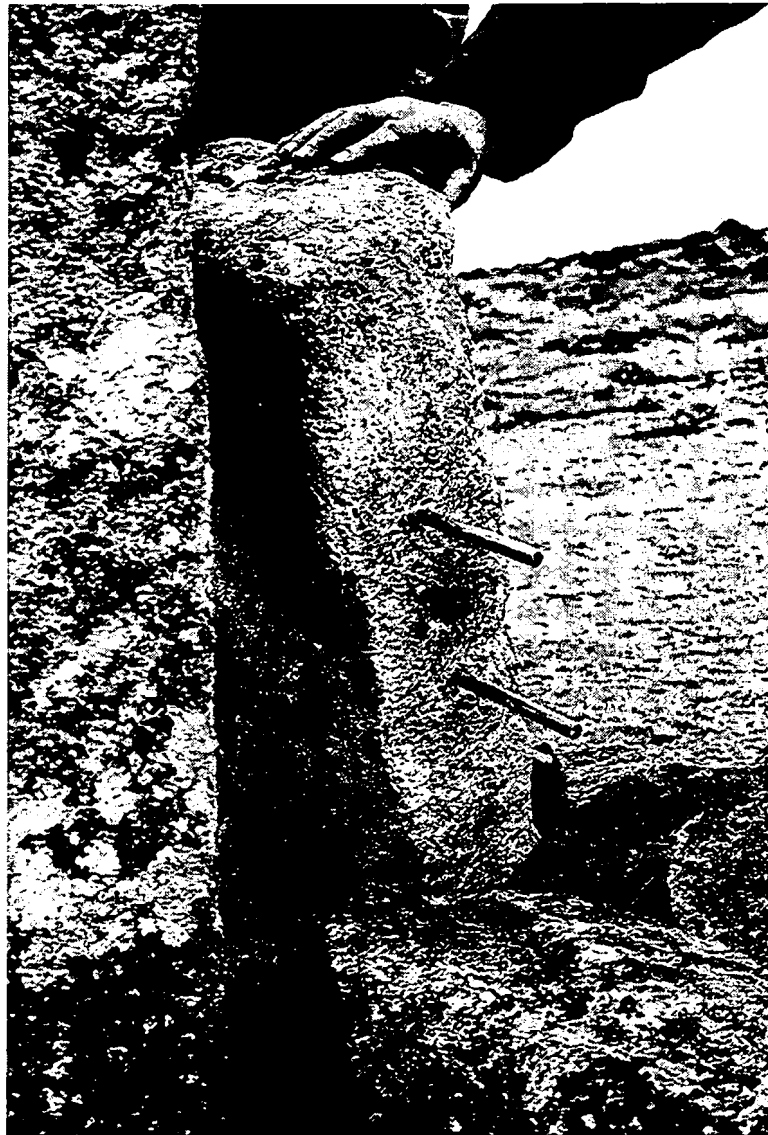
*Fig 4 The cross head, showing new stainless steel pins*

At Tynes Quarry, two new 5 inch deep holes were drilled in the head, to either side of the original dowel hole, and stainless steel pins inserted, set in stone glue (Fig 4). The iron clamp was removed and the hole filled with a mixture of glue and stone dust, and the opportunity also taken to renew the central fittings of the upper section of the head.

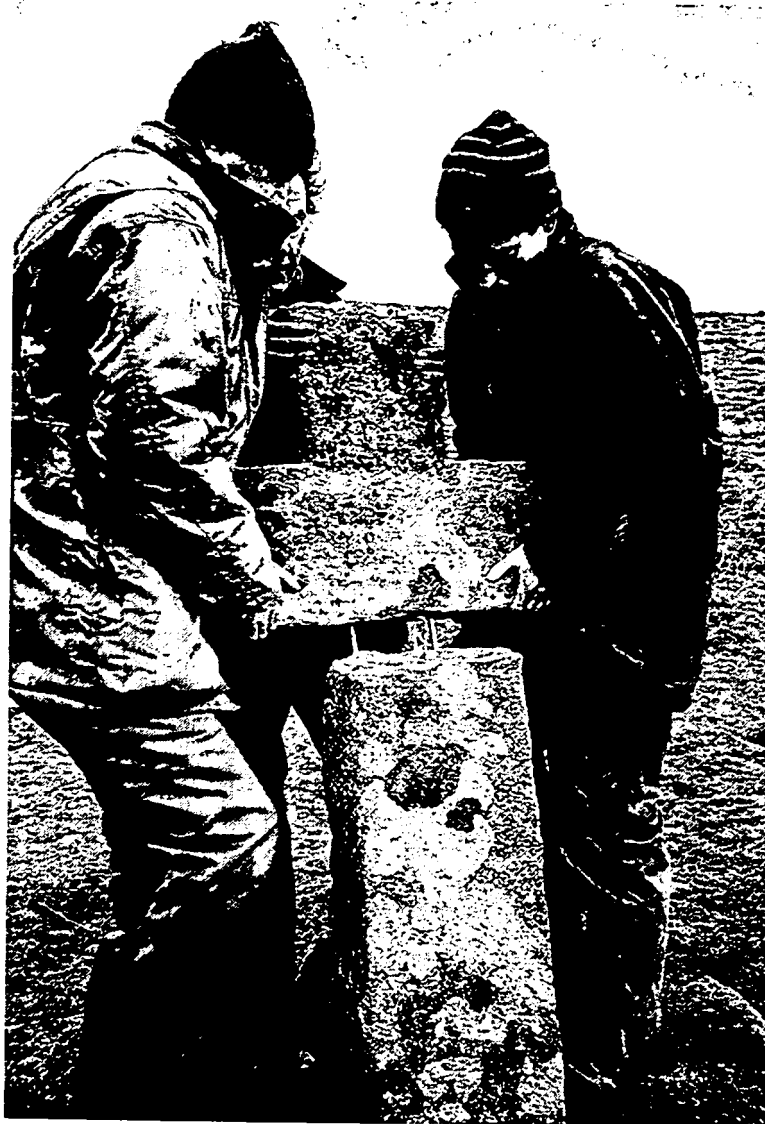
*Fig 5 Reassembling the cross. Ernie Hillson, David Attwell and Mike Millard lift the cross-head back onto the shaft*

Back out on site, the monument was reassembled. A portable compressor and drill were taken out to enable the two 5 inch holes for the pins to be drilled in the top of the shaft. Having filled these with stone glue, the head was then re-fitted to the shaft, bedded on a layer of glue. The joint was finished with a mix of glue and stone dust, which blended almost invisibly with the granite of the cross and should weather to a rough, stone-like texture.

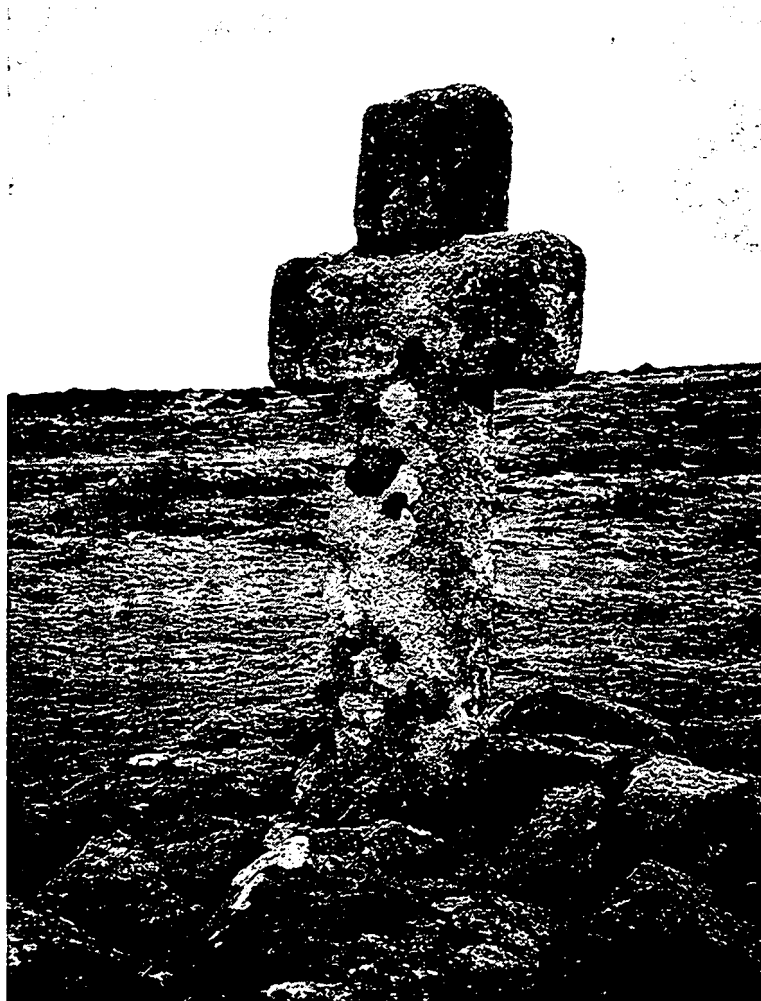
In restoring the cross, considerable care was taken to ensure that the lichens and mosses growing on it were damaged as little as possible. As a result, it now looks unchanged and as though nothing ever happened. This is excellent; but two points should be flagged up for future monitoring:

1. The old central iron pin was not removed. In the long term, if water penetrates the joint, this will corrode and expand and may cause the shaft to crack. Unfortunately, it may not be until cracking occurs that the problem is apparent. But this will not happen in the short term, as the joint is a tight one and at present sealed by the glue.
2. Extensive use was made of stone glue in fixing pins, bedding joints, and finishing joints. Use of this medium in particular to finish joints when mixed with stone dust

may be a traditional method in stone masonry nowadays but has never been used before in a project financed by CAU. At this stage, it certainly looks good, but it will be interesting to see how it weathers in the long term.

*Fig 6 The restored cross*
